Investigation of the Performance of the New Orleans Flood Protection Systems in Hurricane Katrina on August 29, 2005

Volume I: Main Text and Executive Summary

**Final Report
July 31, 2006**

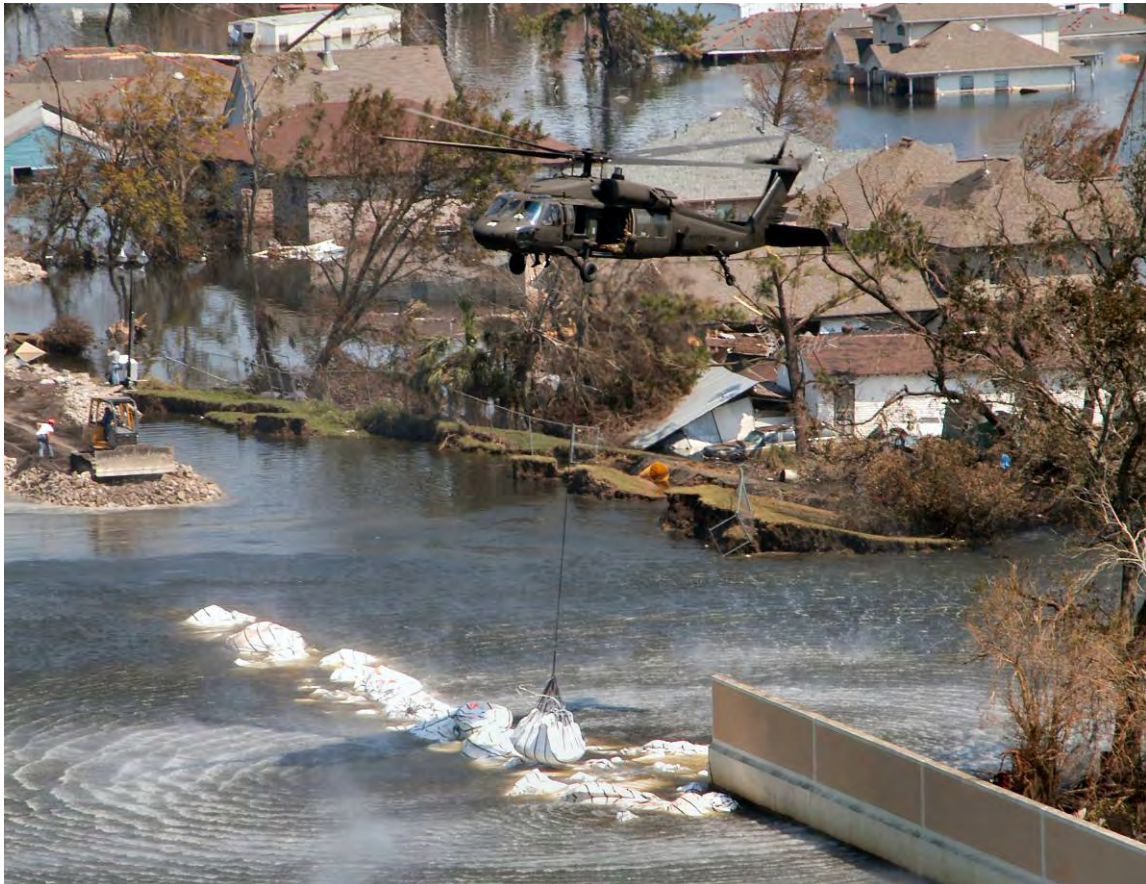
Figure 2.14: Initial closure of the large breach at the north end of the 17th Street Canal.

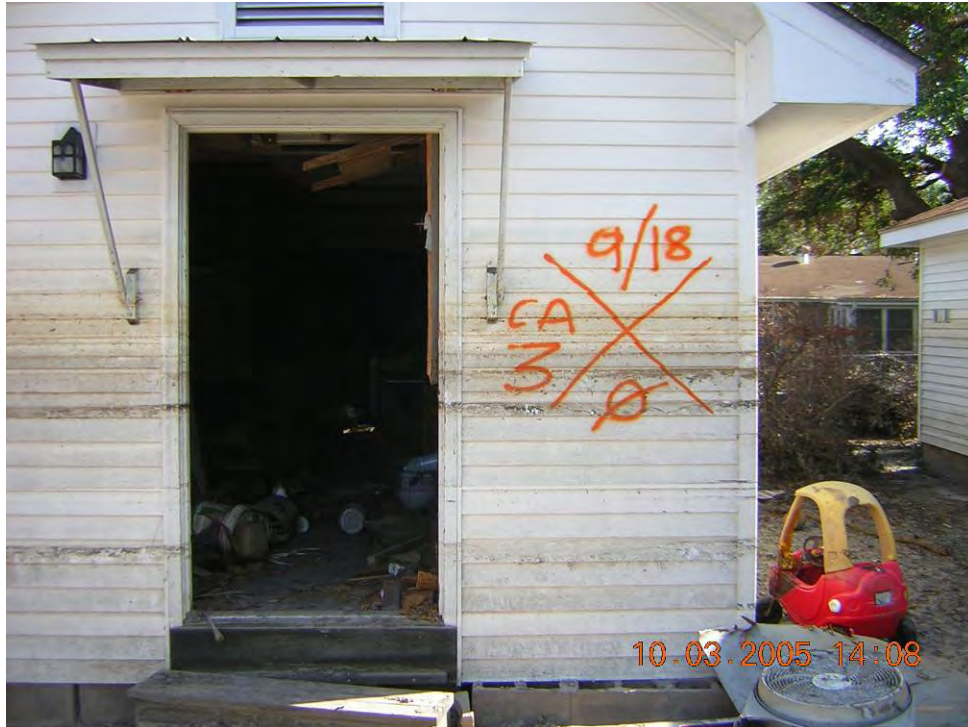
Figure 2.18: High water marks remain on structures after temporary levee repairs have been completed and flood waters have been pumped out.

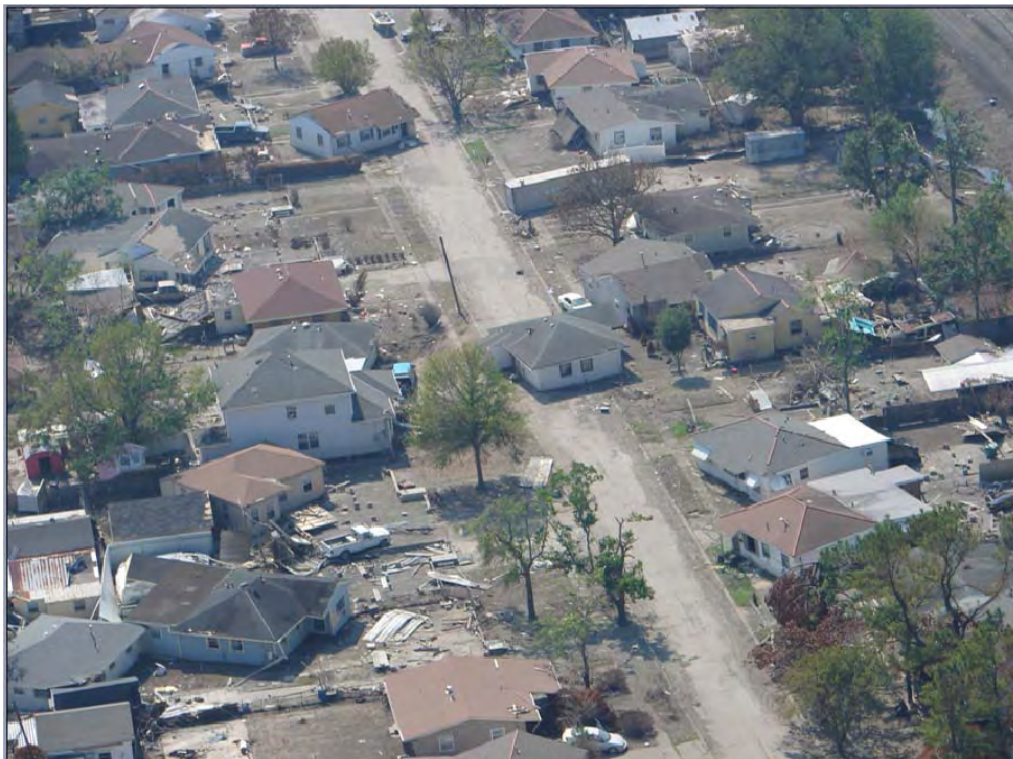
Figure 2.19: Flooded neighborhood in St. Bernard Parish, showing homes floated off their foundations and transported by floodwaters.

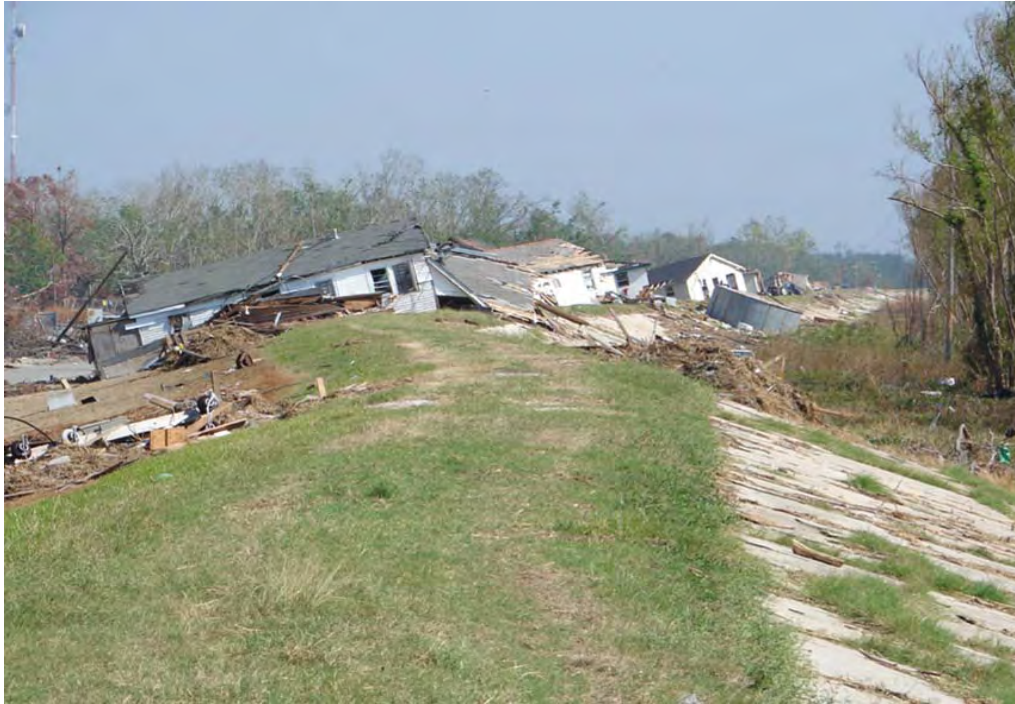
Figure 2.20: Homes in Plaquemines Parish carried from left to right in photo and strewn across the crown of the Mississippi Riverfront levee.

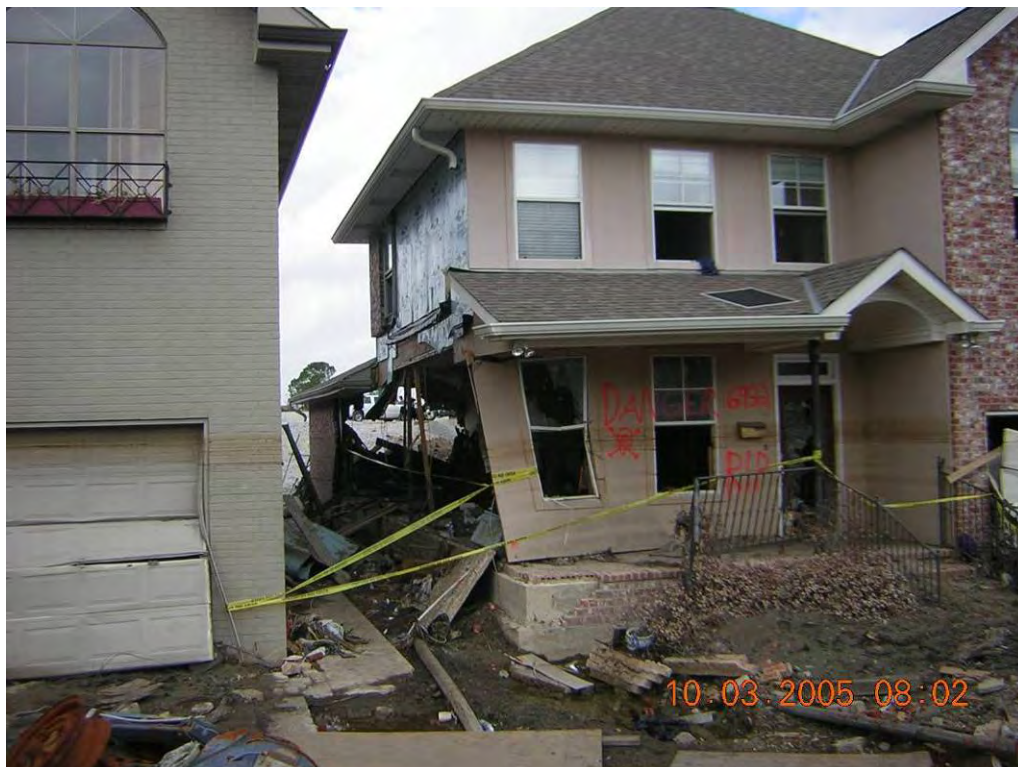
Figure 2.21: Damage to a residential neighborhood in the 17th Street Canal area due to flooding.

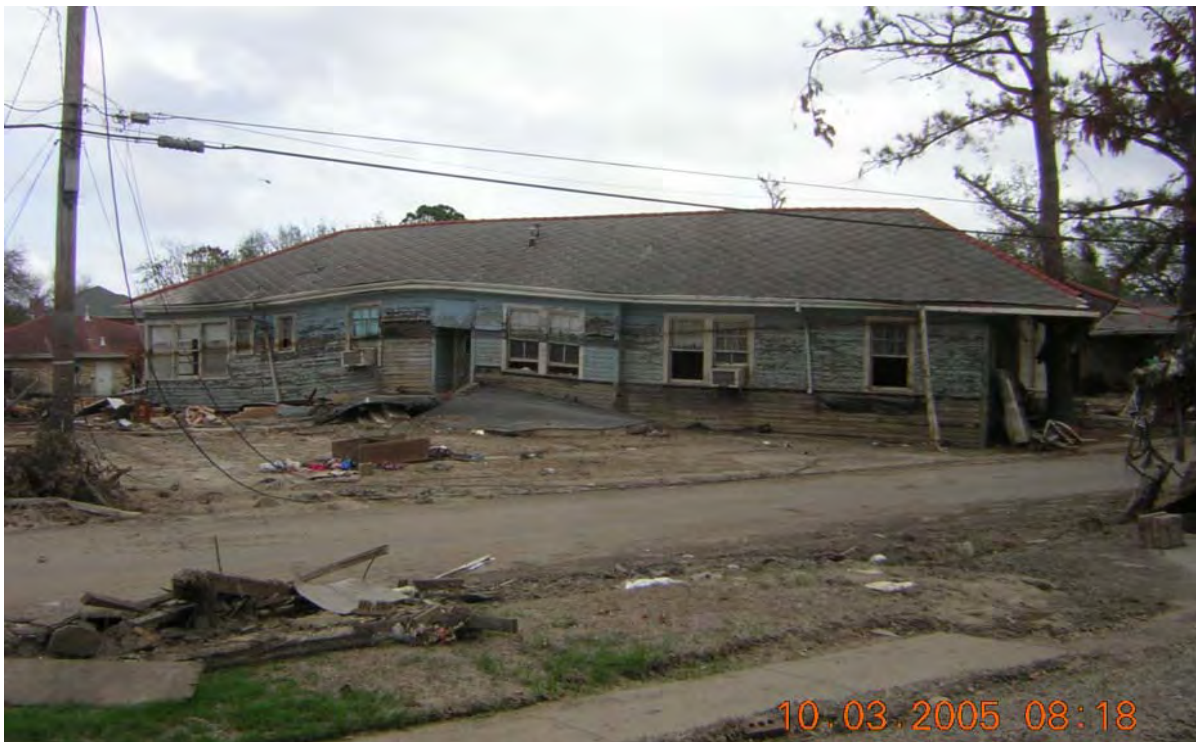
Figure 2.23: Another view of flooding damage in the Canal District.

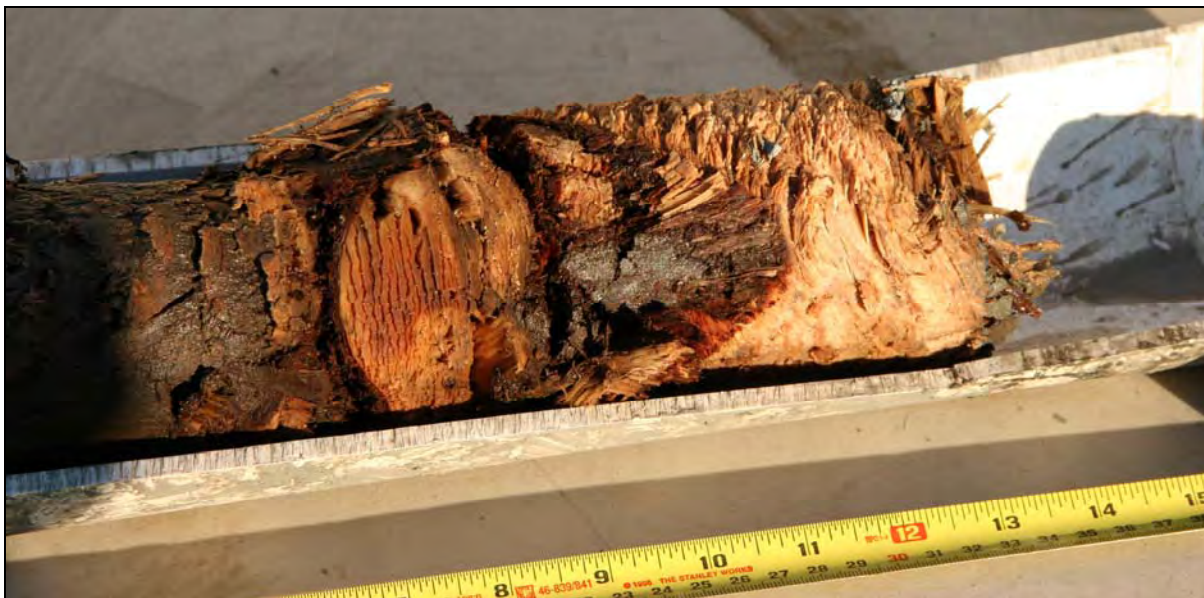
Figure 3.15: Wood and other organic debris was commonly sampled in exploratory borings carried out after Hurricane Katrina throughout the city. This core contains wood from the old cypress marsh that was recovered near the 17th Street (Metairie Relief) Canal breach. Organic materials are decaying throughout the city wherever the water table has been lowered, causing the land surface to subside (photo by C. M. Watkins).

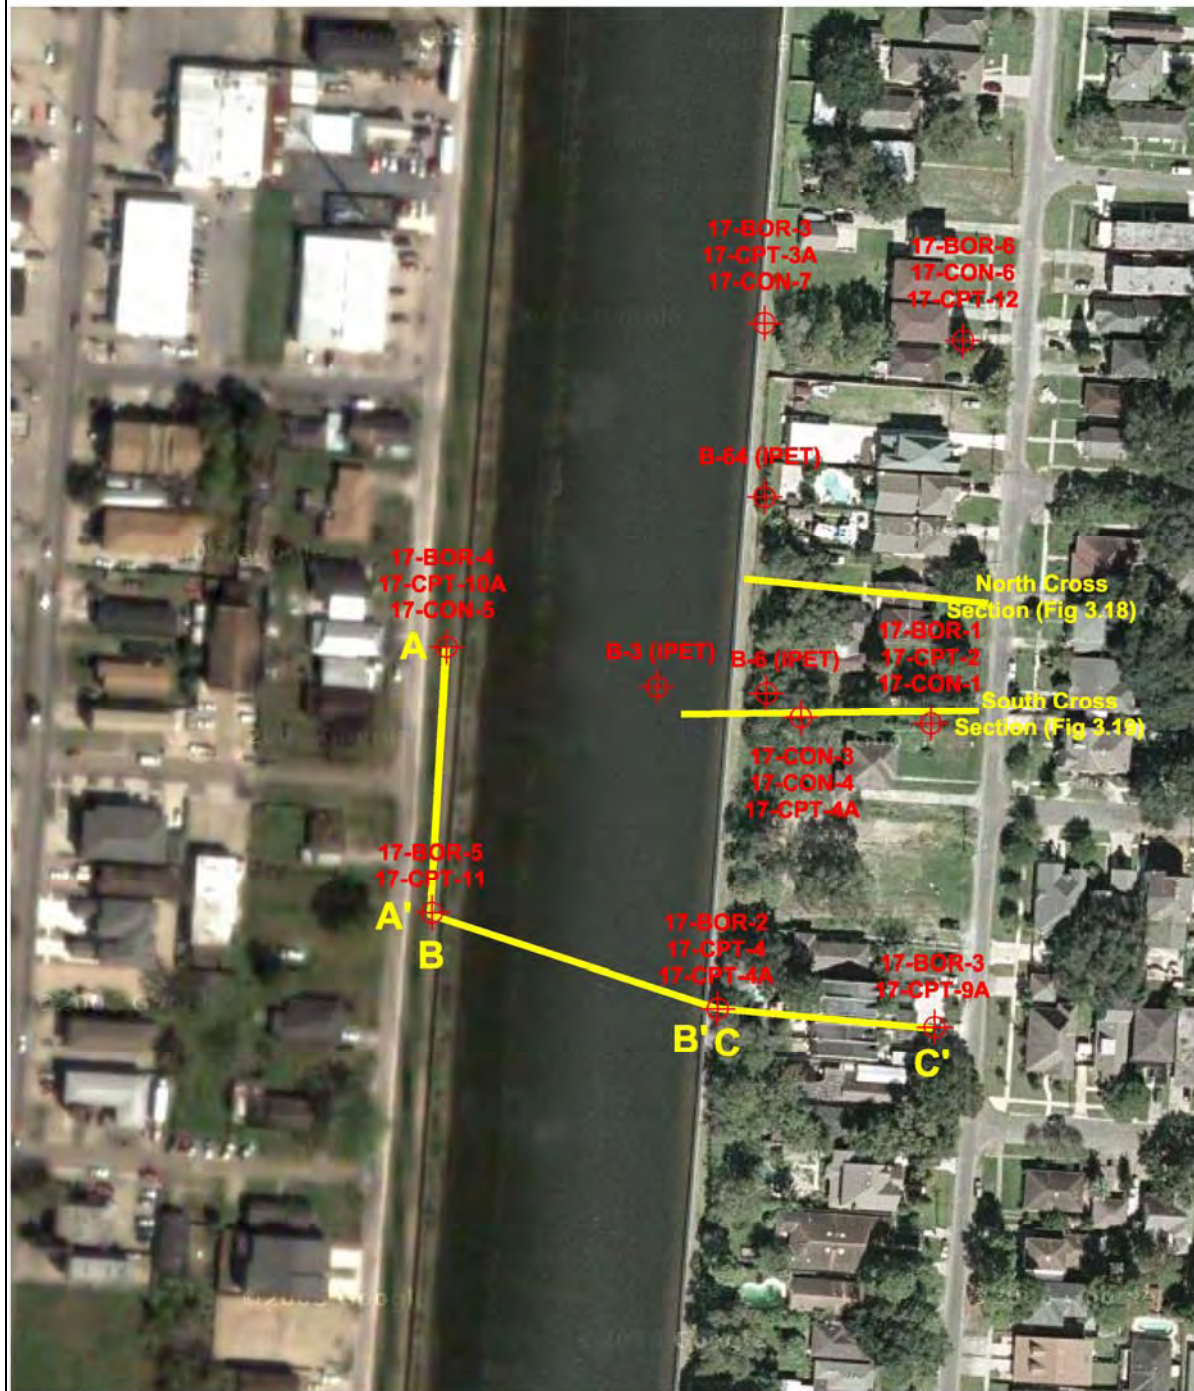
17th St. OUTFALL CANAL LEVEE BREAK BORING AND CROSS SECTION LOCATIONS

Figure 3.17: Aerial photo of the 17th Street Canal breach site before the failure of August 29, 2005. The yellow lines (at middle right) indicate the positions of the geologic sections presented in Figures 3.18 and 3.19, while cross sections A-C' are shown in Figure 3.21.

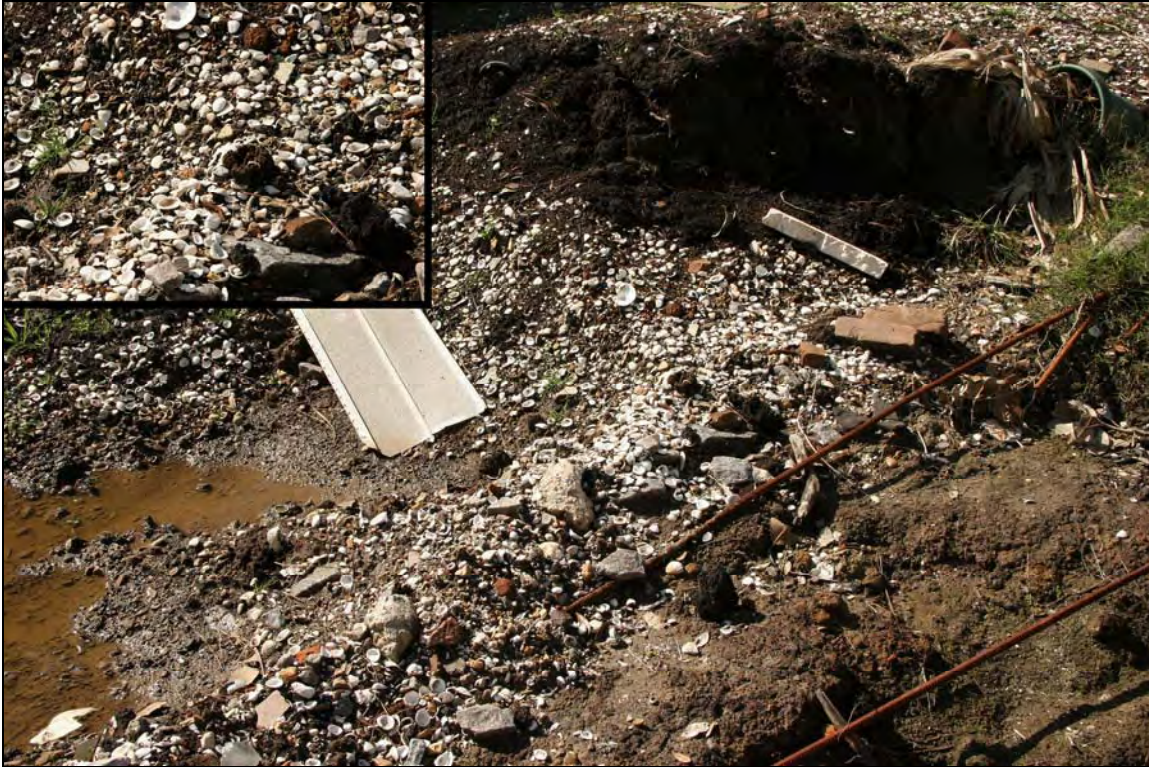
Figure 3.20: Bivalve shells ejected by high pore pressures emanating from toe thrusts on landside of failed levee at the 17 Street Canal (detail view at upper left). These came from a distinctive horizon at a depth of 2 to 5 feet below the pre-failure grade (photo by C.M. Watkins).

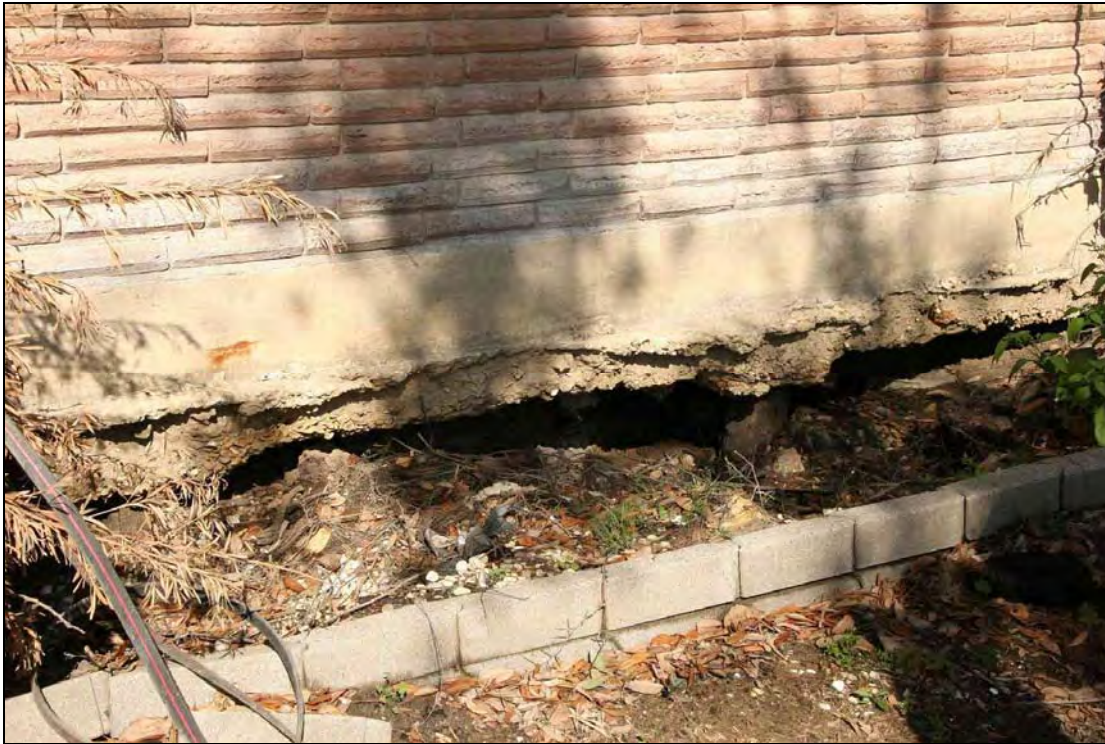
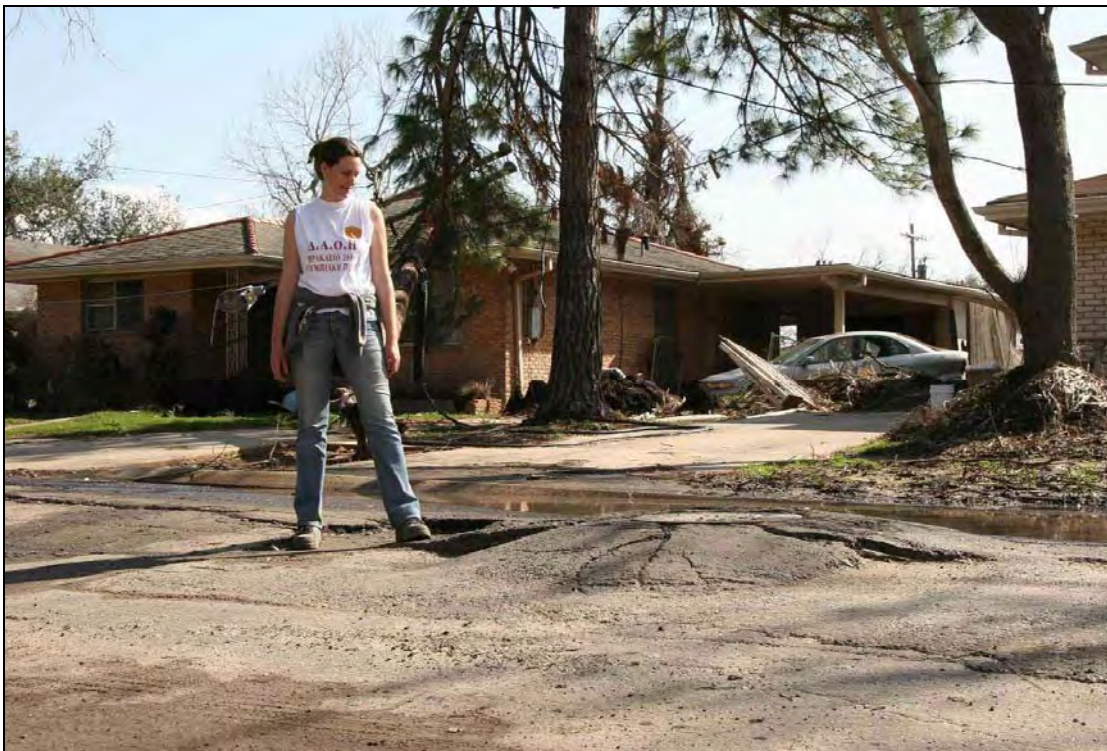
Figure 3.28: Upper photo shows gross near-surface settlement of homes in the Lakeview neighborhood, close to the 17th Street Canal breach. Most of the homes were constructed from 1956-75 and are founded on wood piles about 30 feet deep. The lower photo shows protrusion of a brick-lined manhole on Spencer Avenue, suggestive of at least 12 inches of near surface settlement during the same interim (photos by J. D. Rogers).

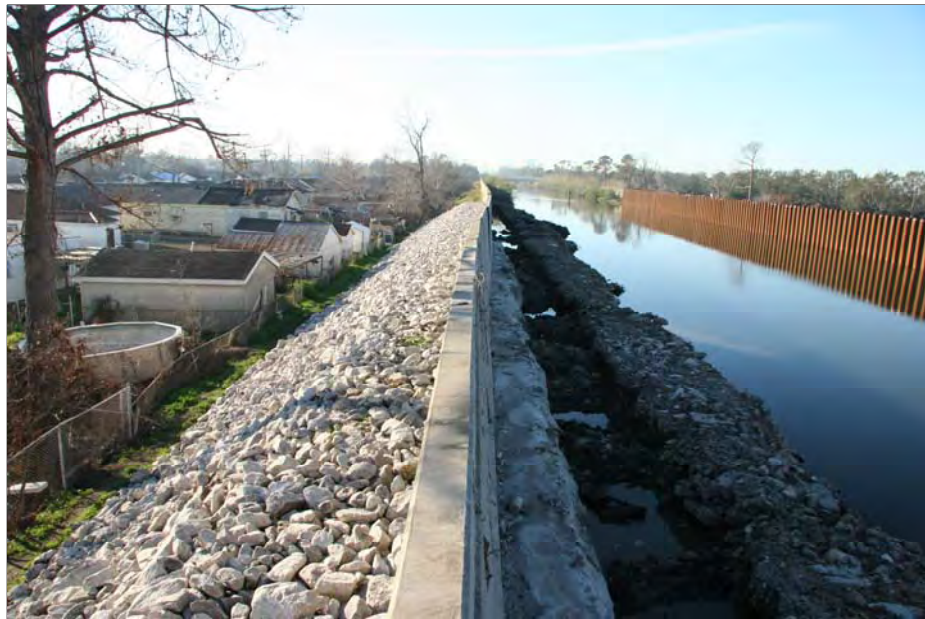
Figure 4.24 (upper): View looking up the east side of the London Avenue Canal near Robert E. Le Boulevard crossing showing the encroachment of homes against the slope of the levee. This situation was common across New Orleans (photo by C. M. Watkins).

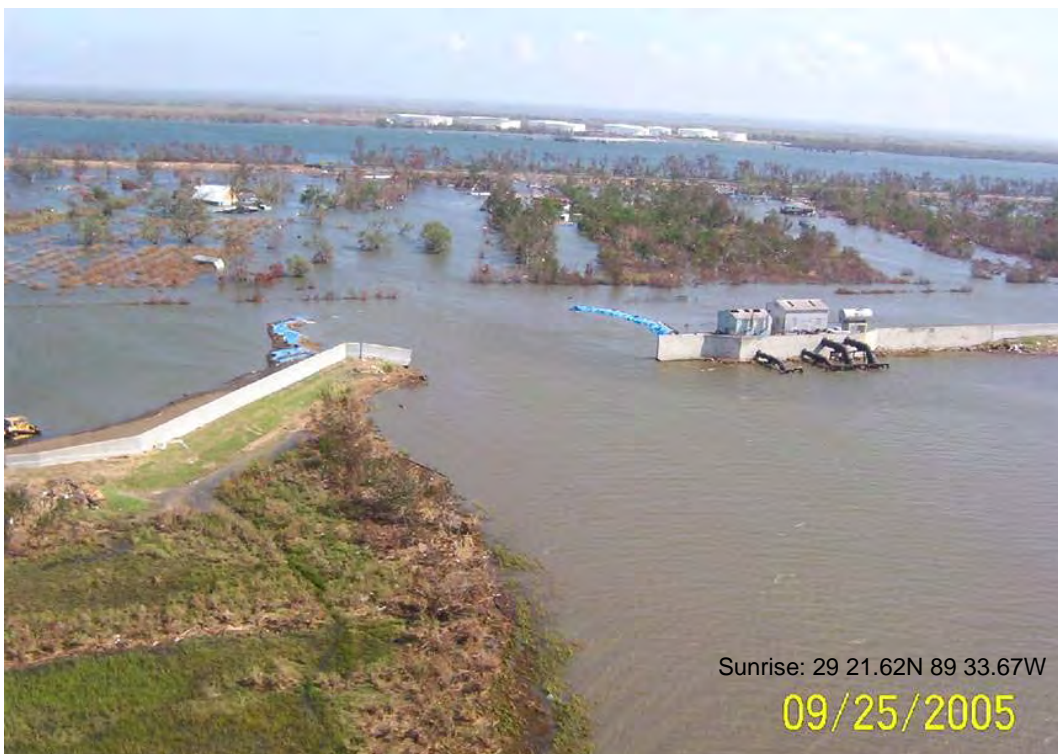
Figure 5.4 shows an aerial photograph of a levee breach of the hurricane (back) levee on the western side of the Mississippi River near the community of Sunrise. The breach occurred at a “transition” between an earthen levee section with a sheetpile-supported concrete I-wall, and a plain structural floodwall section. Failures at transitions between different adjoining sections were relatively common throughout the affected area during Hurricane Katrina.

Figure 5.4: Aerial photograph of levee breach of storm (back) levee along western side of the Mississippi River near the community of Sunrise. [September 25, 2005]

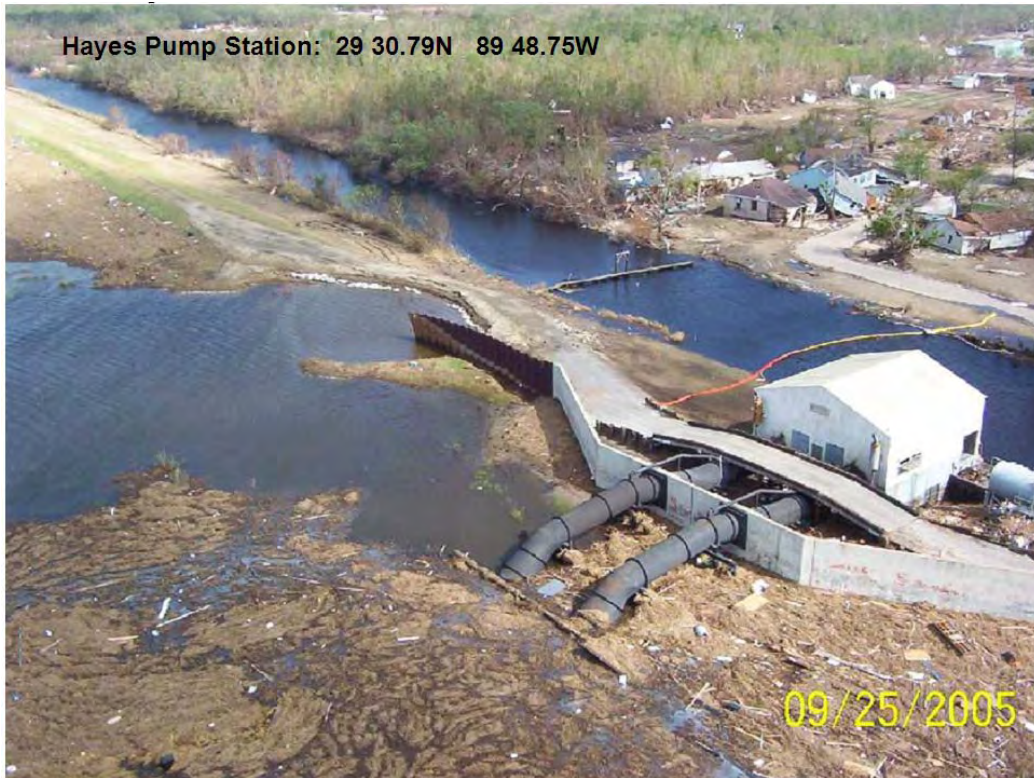
Figure 5.5 shows an aerial photograph of a breach of the hurricane (back) levee at another “transition” near the Hayes Pump Station. This time the failure occurred at a sheetpile transition between an earthen embankment and a structural floodwall section, and sheetpile to earthen embankment connection appears to have been the weak link.

Figure 5.5: Aerial photograph of levee breach of storm (back) levee at levee-to-wall transition near Hayes Pump Station. [September 25, 2005]

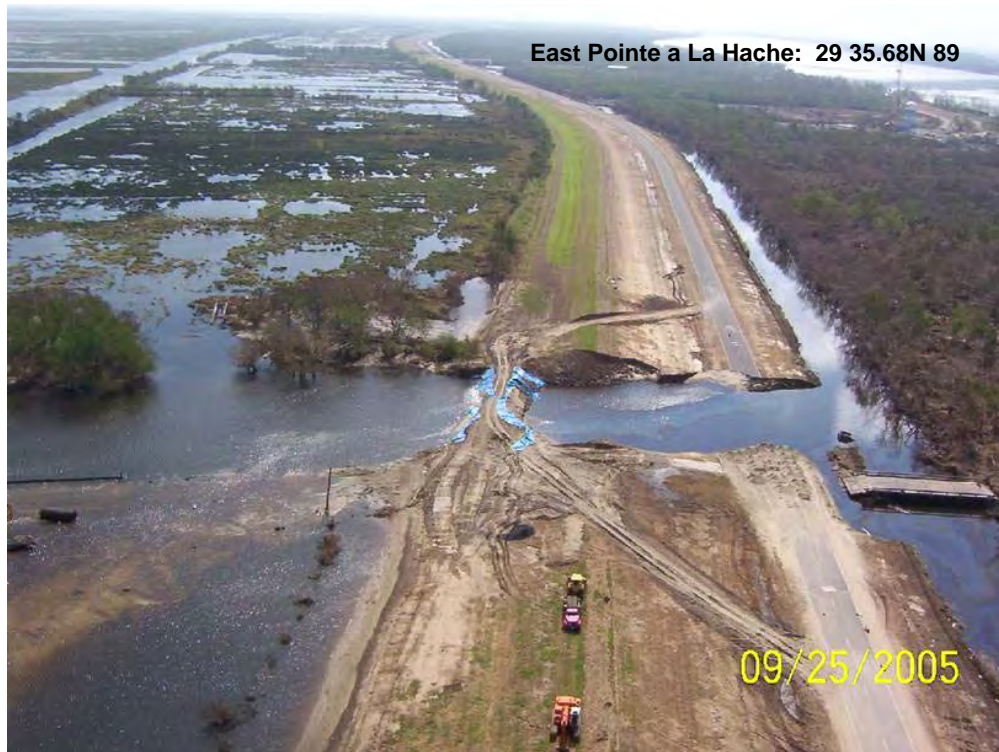
Point a la Hache is the parish seat for Plaquemines Parish and is located along the east side of the Mississippi River. Storm surges from the east largely overwhelmed the back levee, breached it in several places, and inflicted deep flooding and widespread destruction in this town. Figure 5.7 presents an aerial photograph of one such breach taken on September 25, 2005 (from Plaquemines Parish Government Website). Shown in this photograph is a temporary road constructed across the interim breach repair to facilitate access and repairs.

Figure 5.7: Aerial photograph of levee breach of storm (back) levee East of Pointe a la Hache. [September 25, 2005]

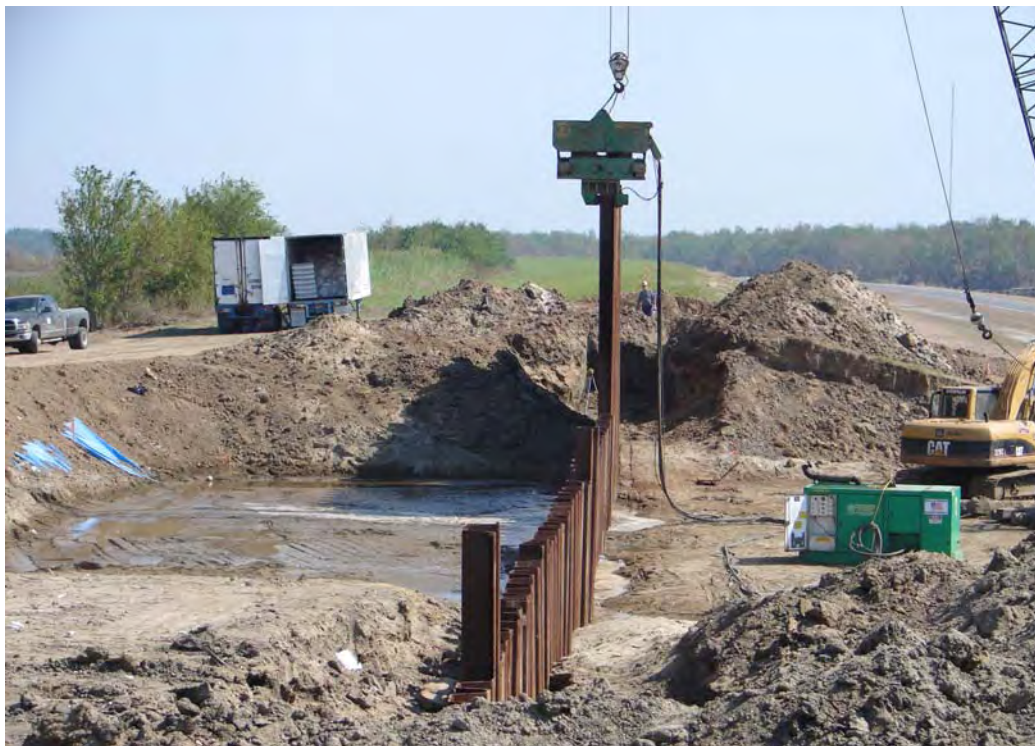
Figure 5.8 shows this same levee breach a few weeks later during the installation of a sheetpile cutoff that was undoubtedly intended to be part of an interim, and perhaps permanent repair. The team members viewing the installation believed that the sheetpile wall was a good concept to affect a positive cutoff of seepage through the deeply scoured breach and loose debris. However, during the installation, team members noted that the contractor was having difficulty advancing the southern portion of the sheetpiles very far into the ground using the equipment in use at the time of the team’s visit. It is hoped that the pilings ended up being driven to their needed depths.

Figure 5.8: Photograph of Sheetpile Cutoff Being Placed into Levee Breach of Storm (Back) Levee East of Pointe a la Hache. [October 12, 2005]

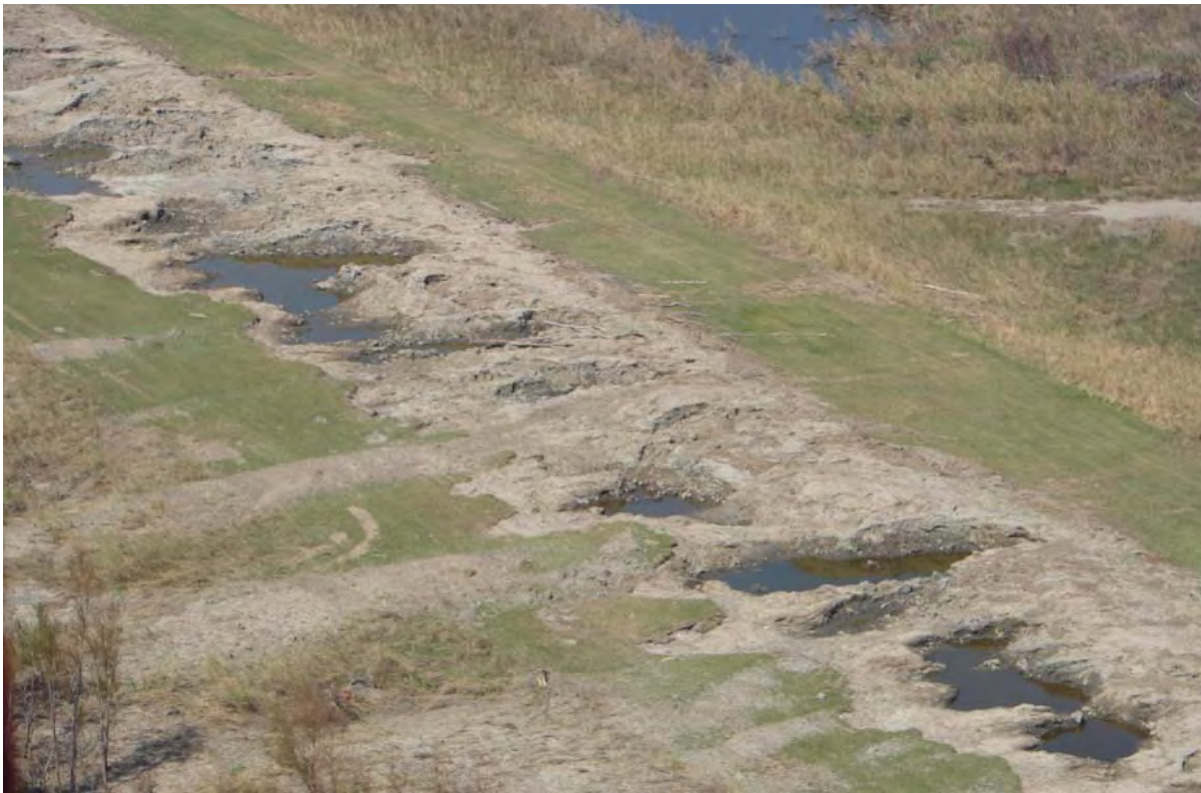
Figures 6.3 and 6.4 show two sections of the levees along this frontage after this event. These are aerial views taken from significant elevation, and they each show many hundreds of feet of levee section that have been catastrophically eroded. In Figure 6.3, the depression in the foundation soils induced by the settlement of the now-vanished levee, and the erosion produced by the turbulent flow across the original levee footprint, is the only sign of the former presence of a levee. In Figure 6.4, a sheetpile curtain had been driven along the centerline of the levee crest, to raise a section that had settled as an interim measure until the

Figure 6.3: Catastrophically eroded levee section along the northeast frontage of the St. Bernard Parish protected basis, fronting the MRGO channel.

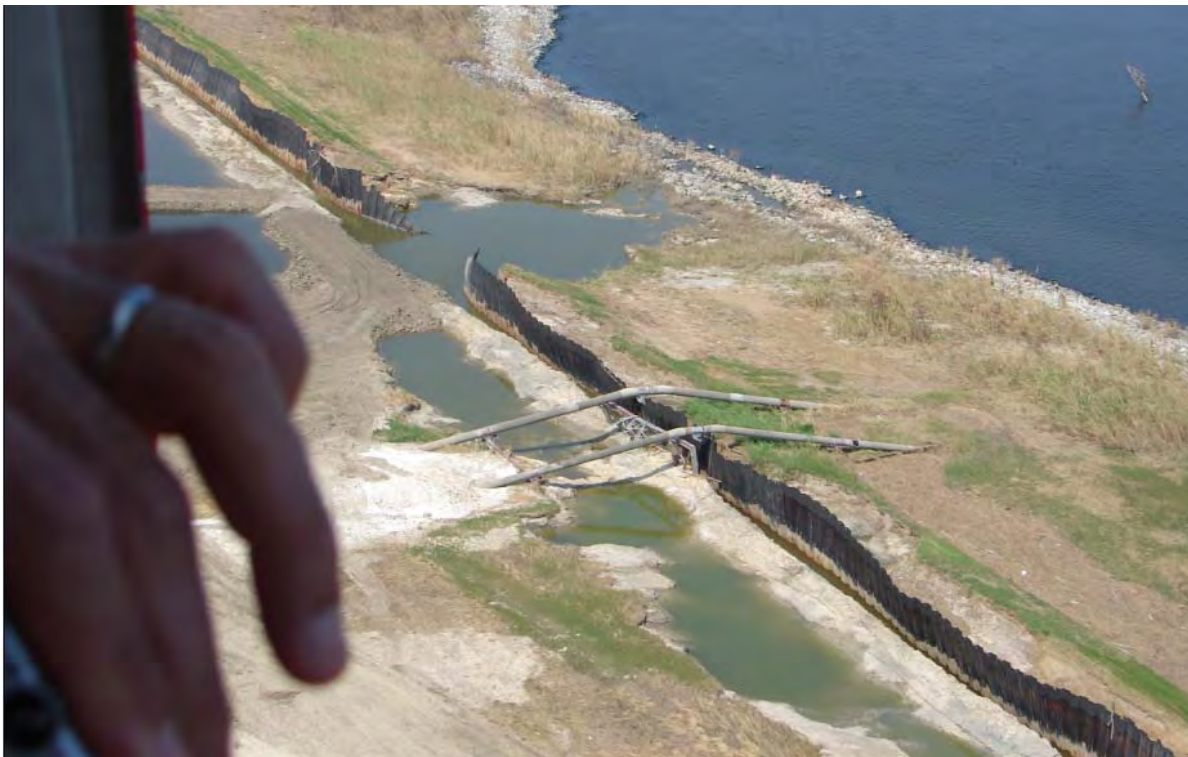
Figure 6.4: Catastrophic erosion of levee embankment leaving central sheetpile curtain; also along the northeast frontage of the St. Bernard Parish protected basin fronting the MRGO channel.

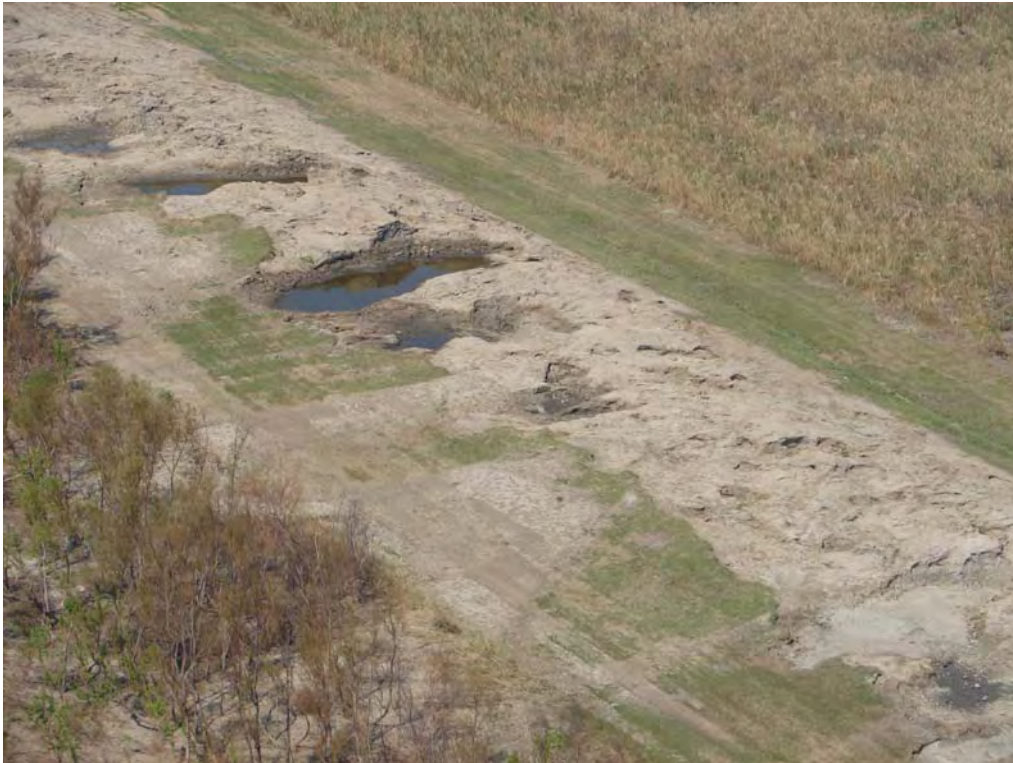
Figure 6.5 shows another view of massive erosion along a long stretch of levees along this “MRGO frontage” section, this time a bit farther to the south (nearer to the second navigational lock structure at bayou Dupres.) Here the massive erosion is not as complete, and portions of the levee embankment remain. In this photo, the eroded detritus can be clearly seen to be strewn back behind the partially eroded levees, and the sandy (and shell sand) nature of some of this eroded material is evident.

Figure 6.5: Extensive erosion of levees along the MRGO frontage at the northeast edge of the St. Bernard Parish protected area.

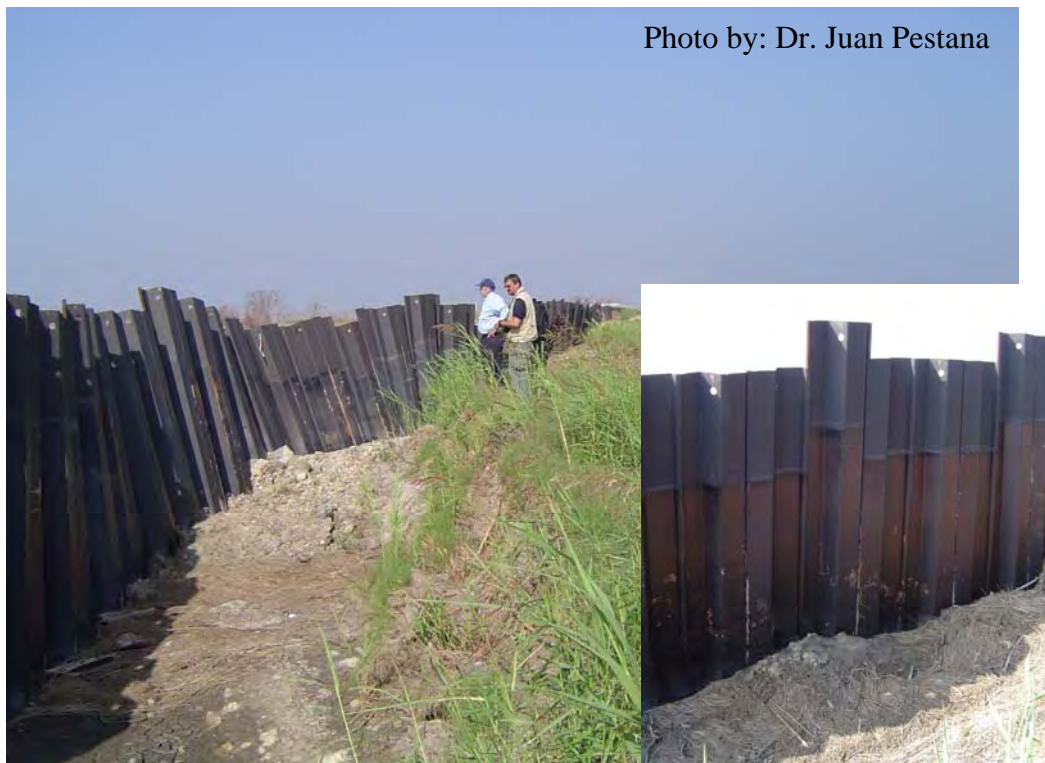
Figure 6.6 shows a ground level view of the sheetpiles from Figure 6.4. In this photo it can be clearly seen that the sheetpiles, which had originally been driven to constant grade, have settled differentially under the pounding of the storm surge and storm driven waves. This would suggest that the cyclic wave loading may have caused pore pressure increases in the fine, sandy foundation soils into which the sheetpiles were embedded, and that this (full or partial) liquefaction reduced the bearing strength and stiffness of these foundation soils and led to the observed differential sheetpile settlements as the sheetpiles were only lightly self-loaded with regard to vertical bearing and settlements.

Figure 6.6: View of sheetpiles left behind at catastrophically eroded section of the MRGO frontage levee.

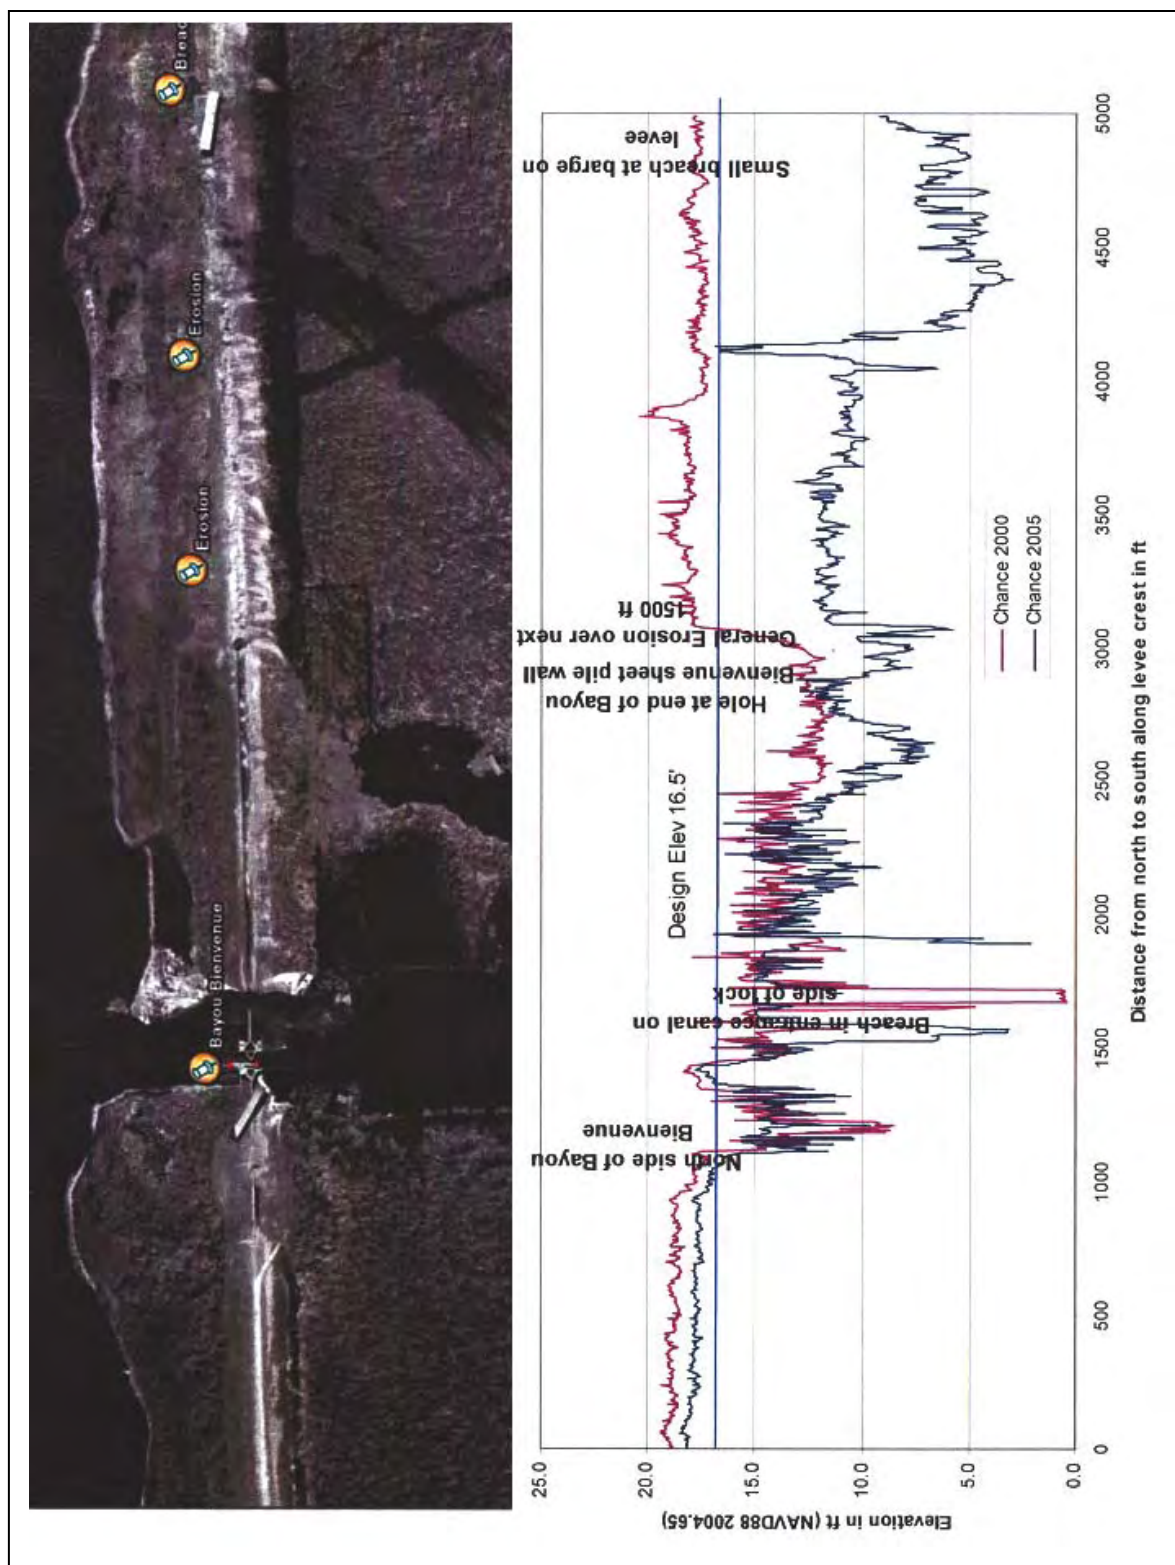
LIDAR surveys were performed by the USACE to document the elevation of the levee crest along the full 11-mile long northeast (MRGO) frontage both before and after Katrina. An example is shown in Figure 6.7, where the magenta line indicates the crest elevation prior to Katrina, and the darker blue line indicates the crest elevation afterwards. The photo at the top of this figure is a vertical (plan view) photographic image along the same section. The two LIDAR surveys serve to show the amount of erosion-induced crest loss along this section, and this can be correlated with the same locations in the photo at the top. Note the light material streamed back behind the levees (on the “protected side”) in the corresponding photo; representing eroded material from the levees strewn back into the inboard side swamps.

Figure 6.7 includes the large (gated) reinforced concrete navigation control structure at Bayou Bienvenue. A large barge was deposited on the crest of the levee immediately to the north of this lock structure, and this can be clearly seen in Figure 6.7. Figure 6.8 shows a second view, of the massive breach eroded at the contact between the lock structure and the adjacent levee embankment.

Figure 6.7: LIDAR survey data showing crest elevations before and after hurricane Katrina along a section of the MRGO frontage levees at bayou Bienvenue, and corresponding post-event plan view aerial photo along the same section.

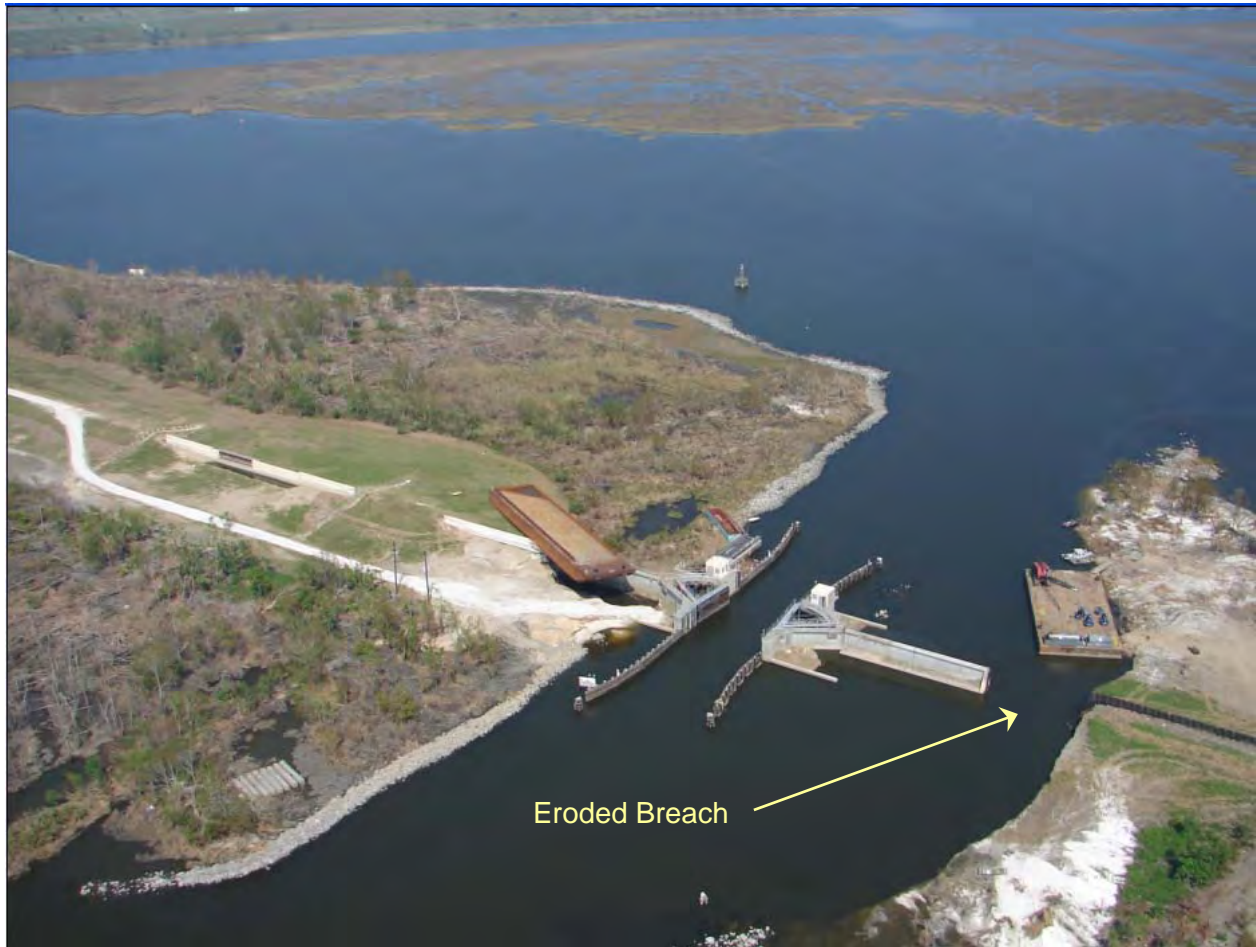
Figure 6.8: Large eroded breach at the contact between the south end of the massive concrete navigational lock structure at Bayou Bienvenue and the adjacent levee section.
